MASONRY ADVISORY COUNCIL

To: Architects, Engineers, Builder Developers / Contractors
From: Charles Ostrander, P.E. Executive Director of the Illinois Masonry Institute
RE: Ramblings and "Everything Changes with time."

AN OLD PROBLEM WITH A NEW “MOLDY” TWIST

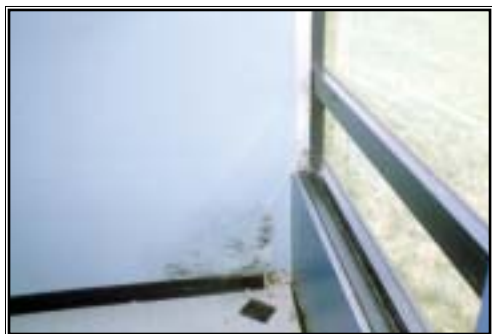
This 1 story local health care facility, built in the late 1970's had “water penetration problems” when it was repaired in the 1980's. Nowadays, it would have also necessitated a mold abatement program.

Notice the mold growing on the drywall near the floor.

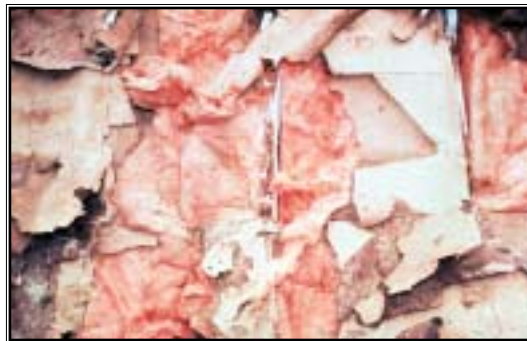
After the brick was removed one can see the corrosion of the steel studs, a black mold growing on the exterior paper of the drywall and saturated batt insulation at the base of the wall.
