Ramblings Part 6 (Continued)

C. Limestone Caps not all Created Equal

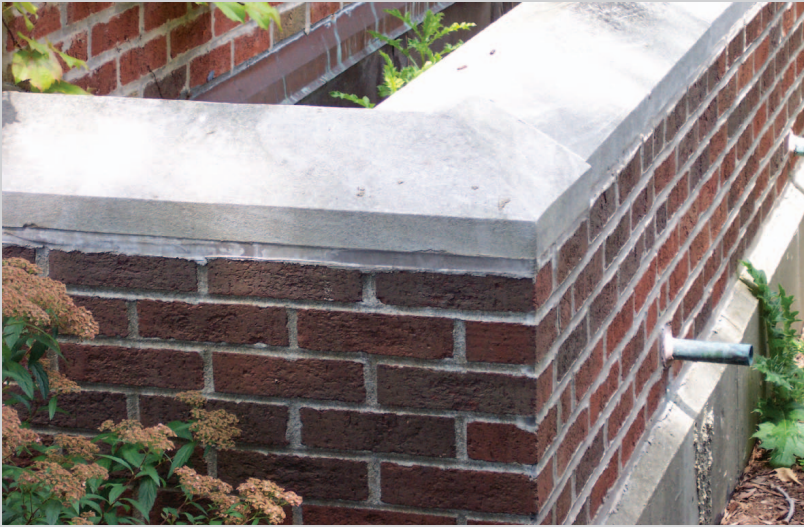
OLD CAP DETAIL

In a previous cover letter regarding flashing, I discussed self adhesive flashing and stainless steel drip edges. I showed photos of my bank (see photo on right) and BIA's Detail from Tech Note 21B (see illustration bottom right). As a follow up to this discussion while a guest at a local golf course (I'm working all the time!), I noticed the recent remodeling and careful detailing of the new masonry and the existing older brick and limestone detailing of the clubhouse. This designer was very careful in matching the original detailing, but he/she updated the limestone cap and flashing detail for the 21st century. Great work!

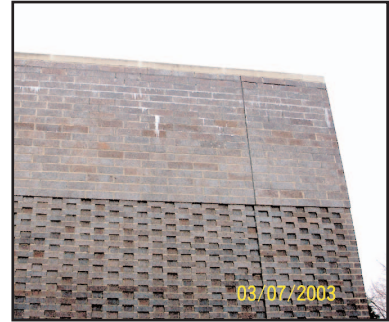
POORLY DETAILED COPING

My Bank: (Note the efflorescence, and the flush limestone cap- it should have had 1 1/2" projection or a drip edge and flashing under the cap)

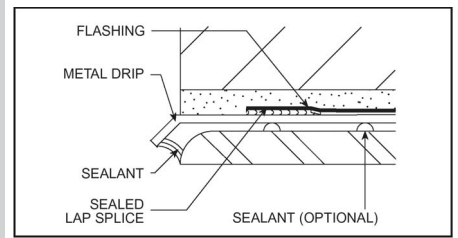
**BIA Detail, Technical Note 21B
Revised, April 2002, Figure 1.**

PROPER DETAIL

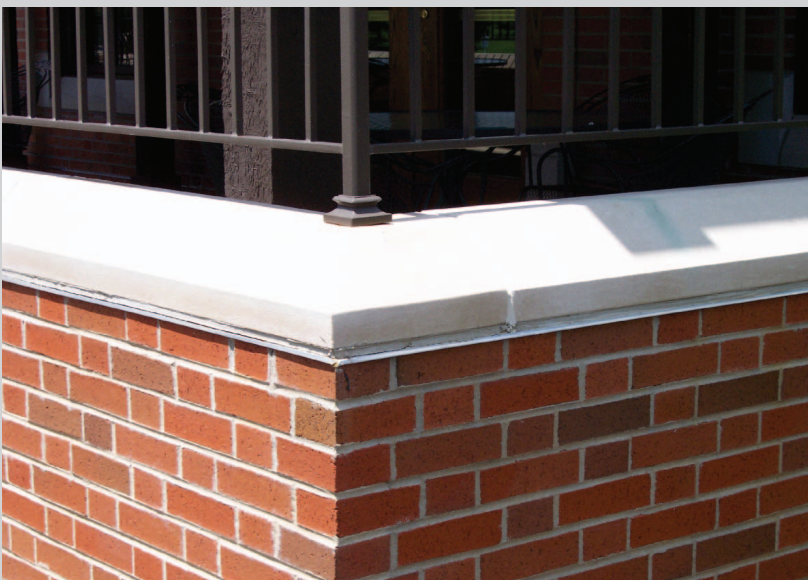
NEW FLUSH CAP WITH EXPOSED DRIP EDGE & FLASHING
