Re: Ramblings Part 6 - Tolerances, Limestone Caps and Vapor Barrier / Condensation Analysis

Ramblings 6

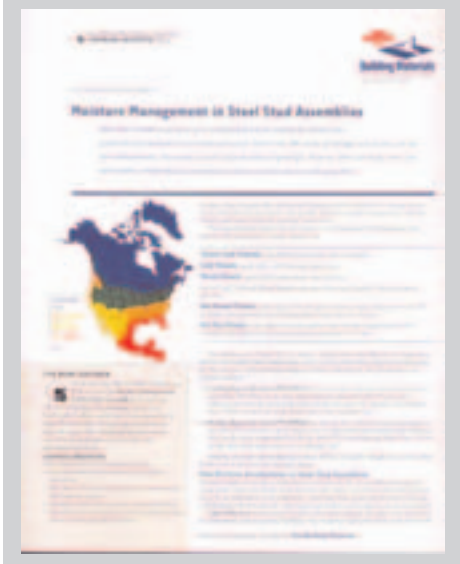
“MOISTURE MANAGEMENT IN STEEL STUD ASSEMBLIES” -DOW

In lieu of batt insulation, many designers are starting to use rigid board insulation continuously outside the exterior sheathing. This insulation can be extruded polystyrene (by Dow, Owens Corning, PACTIV, etc.) or foil faced Polyisocyanurate insulation (by Dow, R-Max, Atlas, etc.) For additional information on this subject (and 1 AIA/CES LU) please review the enclosed “Moisture Management in Steel Stud Assemblies” by Dow. A vapor barrier analysis by your mechanical engineer will also play a more critical part in the design of your next exterior wall system.

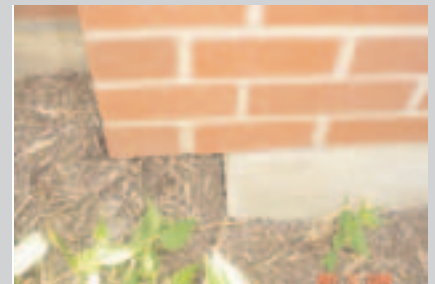
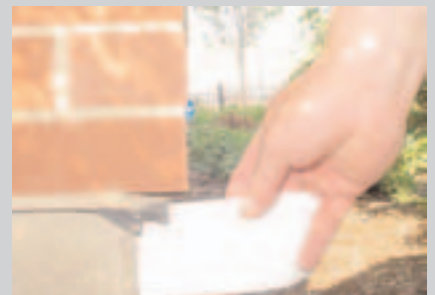
BRICK HANGOVERS

Ask your low-priced concrete contractor if they have ever heard of ACI 117 – “Tolerances for Concrete Construction”. The concrete footing, under 3.2-lateral alignment, supporting masonry, can be +/- 1/2”(if the footings are that accurate, why can’t the placement of forms and concrete walls above them be as accurate?); You know in the photos to the right something is wrong! Lately, some owners are lucky if their concrete foundation walls are on the right lot! Corbelled, unreinforced masonry can overhang a foundation wall by up to 1/3 its bed depth with 2/3 bearing on the concrete wall. [For a 3 5/8” bed depth brick that means an overhang of about 1 1/8”. This would mean 2 1/2” of the brick would be resting on the foundation.] If there is more than 1 1/8” overhanging the foundation, an engineer should be contacted to design a small angle to be bolted into the foundation wall to support the brick.

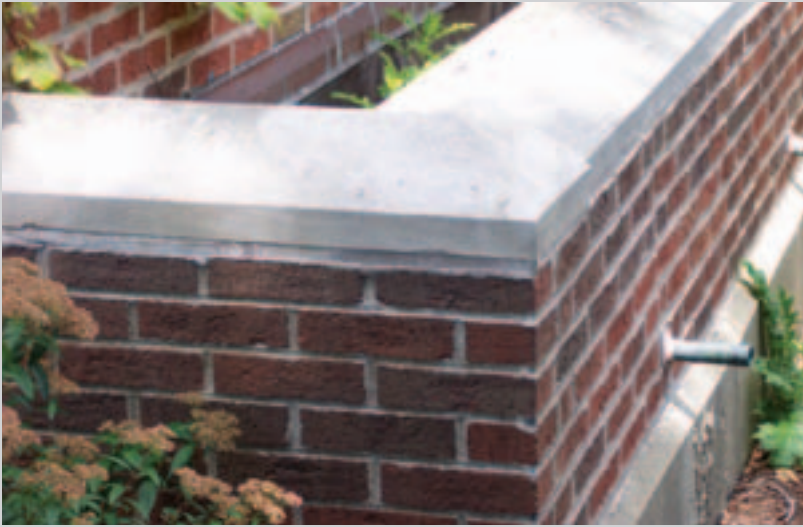
OLD CAP DETAIL

In a previous cover letter regarding flashing, I discussed self adhesive flashing and stainless steel drip edges. I showed photos of my bank (see photo on right) and BIA's Detail from Tech Note 21B (see illustration bottom right). As a follow up to this discussion while a guest at a local golf course (I'm working all the time!), I noticed the recent remodeling and careful detailing of the new masonry and the existing older brick and limestone detailing of the clubhouse. This designer was very careful in matching the original detailing, but he/she updated the limestone cap and flashing detail for the 21st century. Great work!

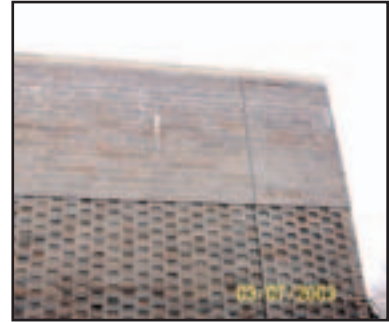
POORLY DETAILED COPING

My Bank: (Note the efflorescence, and the flush limestone cap- it should have had 1 1/2" projection or a drip edge and flashing under the cap)

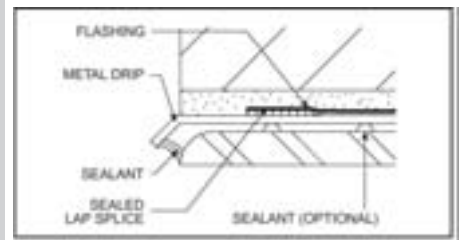
PROPER DETAIL

**BIA Detail, Technical Note 21B
Revised, April 2002, Figure 1.**

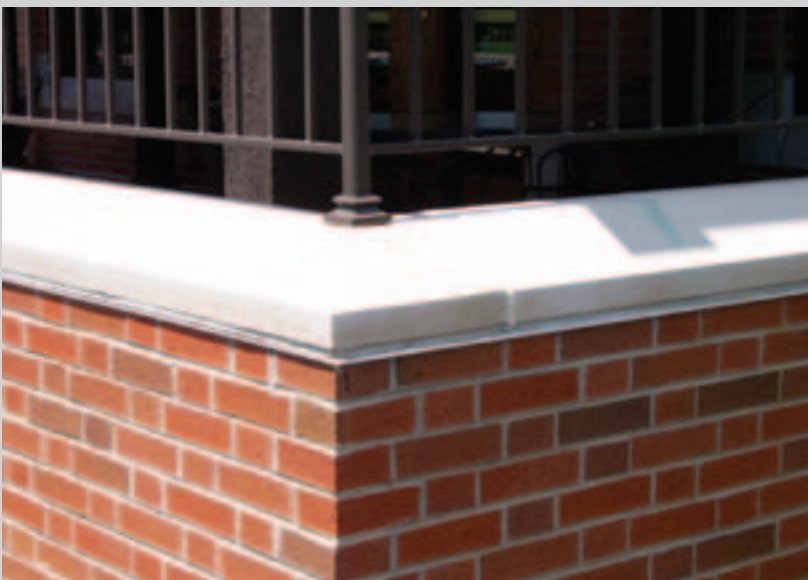
NEW FLUSH CAP WITH EXPOSED DRIP EDGE & FLASHING
